HAZARD ALERT

HOOK SMASHES THROUGH WINDOW, STRIKES WORKER

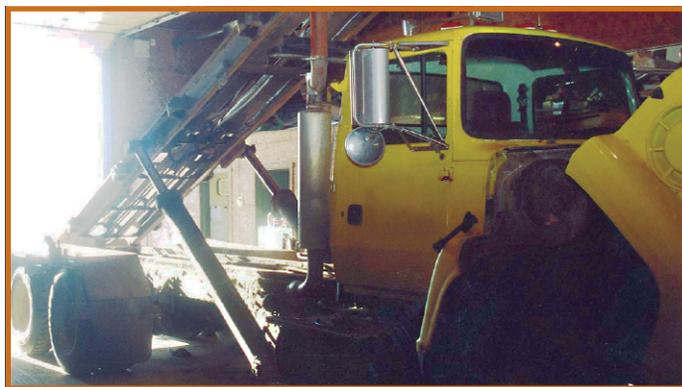
A winch cable was mounted on the roll-off truck, but it was not long enough to reach the container. To pull the container, the operator used a grab chain with a small eight millimetres ($\frac{5}{16}$ -inch) cast hook. He hooked the grab chain between the container and the 7 ½-tonne-rated hook on the end of the winch cable. Once the container was positioned at the edge of the flatbed, the operator tried to pull the container onto the roll-off truck.

Because the truck's bed was not tilted enough to allow the container to properly roll onto it, the container became stuck against the backend of the roll-off truck bed. The winch continued to pull, but the container did not move, causing the small hook on the grab chain to break. The 7 ½-tonne-rated hook and winch cable whipped back toward the rear window of the cab, where the operator was facing backward to observe the operation. The hook went through the rear window, striking the operator in the forehead.

- Never use chain, rope or any other connecting device between the winch cable and the container.
- The winch cable hook must have a safety latch so that the hook cannot inadvertently become unhooked.
- The bed of the roll-off truck must be tilted as per manufacturer's instructions, so the operation can be accomplished safely.
- The rear window of the roll-off truck should be provided with adequate protection such as a screen, shield, grill, deflector or guard to protect the operator from the hazard of flying or intruding objects.
