HAZARD ALERT

FALL ARREST EQUIPMENT MUST BE USED ACCORDING TO MANUFACTURER'S RECOMMENDATIONS

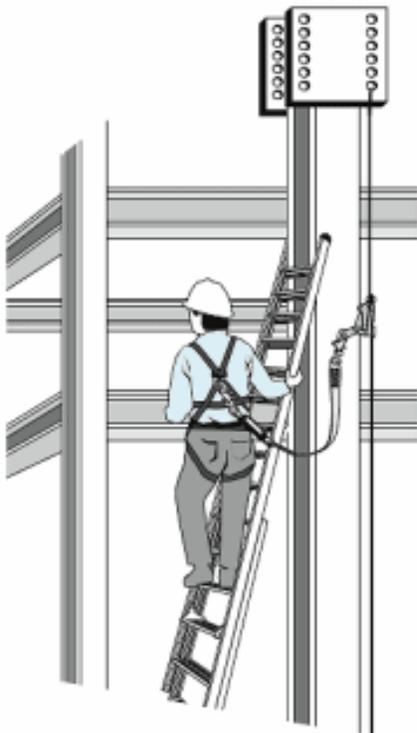
The investigation found that while he was wearing personal fall arresting equipment, it failed to prevent his fall because it was improperly used. The equipment involved in the incident included a full-body harness, a six-foot lanyard with shock absorber, a rope grab and a vertical lifeline. It is suspected that the rope grab may have been improperly attached (reverse orientation) to the vertical lifeline. The employee lost his balance, fell, and the rope grab failed to arrest his fall because reverse orientation did not allow for the arresting mechanism to deploy. Even if the rope grab had been installed properly, the fall may still have occurred because the lanyard was longer than the manufacturer's recommended length of four feet.

1. Whenever there is a risk of a fall from an elevation, employers are required by law to provide their employees with the appropriate fall protection system.
2. The employer is also required to ensure employees are instructed and trained in the proper use and care of the protective equipment, fall protection system for the area, the post-fall rescue procedure and, where applicable, the fall protection code of practice.
3. The law requires that employees continually use the fall protection system as instructed.
4. The law also requires that equipment be used as directed by the manufacturer. This information is usually found in the user's manual or on the equipment itself.
5. If unsure of the proper use of the equipment, you must contact the manufacturer for clarification.
