## **SUPERVISOR CRUSHED UNDER FALLING WALL PARTITIONS**

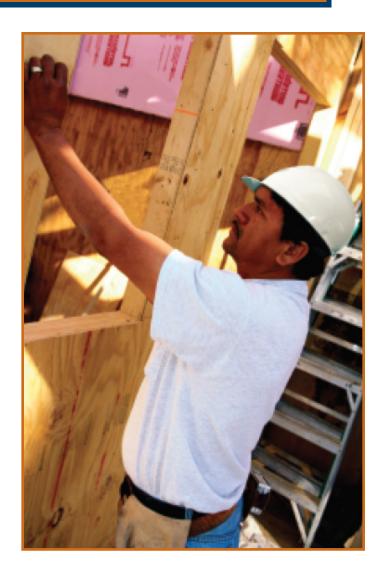
While attempting to support a load weighing in excess of 450 kilograms (1,000 pounds), a supervisor in a pre-manufactured home plant sustained a serious head injury. Assisted by two employees who were trying to retrieve the fifth wall partition from a stack leaning against a wall, they gradually leaned one at a time toward the supervisor who was attempting to support them. In the process, he lost his grip, could not escape and became pinned under the walls. He was taken to the hospital, where he died a month later.

- The supervisor was wearing a hard hat at the time of the incident.
- Employees did not have a good general understanding of the weights they were attempting to manually handle.
- Small items of scrap may have caused the supervisor to slip while supporting the partitions.
- It was not normal to have this many partitions stacked at one time.

- Materials and objects such as walls, windows and doors should be stored in racks or secured in a way to prevent them from injuring employees.
- Employees should be made aware of the weight and push/pull forces that are required to manually handle objects.
- The employer should develop a manual handling code of practice that reduces employee exposure to lift and push/pull forces over 23 kilograms (50 pounds).
- The employer should monitor manual handling operations and provide appropriate training and equipment to reduce manual handling risks.
