HAZARD ALERT

FROZEN "MUSHROOM CAP" HANDLE TRAPS WORKER INSIDE FREEZER

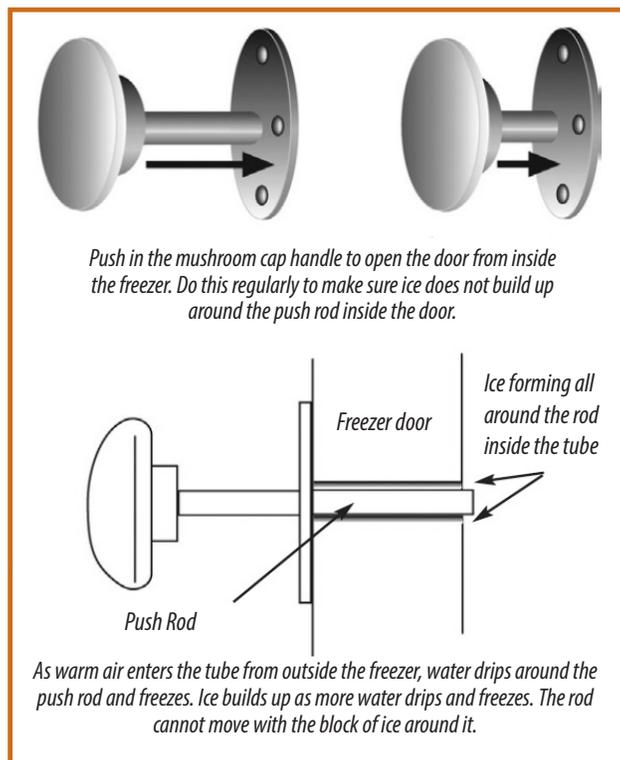
The freezer door could not be opened because the push rod of the mushroom-cap handle was surrounded by ice and could not be moved without significant force. The freezer door was usually open while a worker was inside, so workers rarely used the mushroom cap. It had probably taken weeks or even months for dripping water to freeze inside the handle.

- Inspect and depress the mushroom cap release handle regularly to avoid ice buildup. Make sure the cap can move in and out easily at all times. Do this as part of your regular safety inspections.
- Make certain employees know how the mushroom cap handle works and how to break the ice if the handle won't move. For example, try to turn or push the knob.
- Ensure employees understand they might need to kick the cap several times or hit it with a heavy object to break the ice inside.
- Develop a code of practice for working alone that contains, but is not limited to:
 - Provisions for an alarm should an employee become trapped in the freezer.
