HAZARD ALERT

TRASH COMPACTOR FATALITY

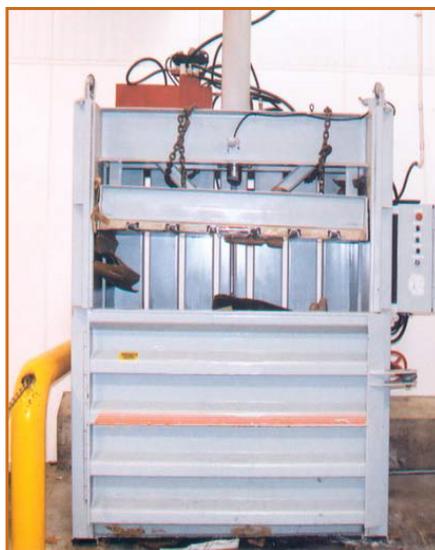
A 22-year-old worker sustained a fatal head injury while checking a vertical cardboard bale compactor. The feed gate was in the open position, and the ramming plate was in the raised position. It is believed that the worker heard a noise in the machine and put his head into the opening to investigate. The hydraulic cylinder that held the ramming plate up in the air broke off at the joint, causing the plate to slide down rapidly. The young worker's head was caught in between the plate and the top of the bale chamber door, causing immediate and fatal injuries.

The unit worked in such a way that when cardboard was piled evenly in the chamber, the plate could come down and crush the cardboard without putting stress on the cylinder rod and connection pin. If, however, cardboard was not placed squarely in the middle of the chamber when the plate was lowered, it compressed the cardboard unevenly, causing stress at the joints.

It was found that the vertical cylinder rod broke due to fatigue at the joint where the rod connected to the pin. Due to repeated bending of the ram during compression of the uneven cardboard, there was excessive force on the connecting area, which led to a failure at the joint. On several previous occasions, the ram became wedged sideways when compressing uneven loads, and a metal rod was used to pry it back into place.

The bale compactor was not certified nor designed by an engineer, and had been in service for only seven months at the time of the incident.

- 1. Proper design:** A bale compactor must be designed using an established standard or code such as the ANSI standard Z245.51-2004 for Equipment Technology and Operations for waste and Recyclable Materials – Baling Equipment – Safety Requirements. The ram and cylinder in all bale compactors should be inspected regularly for any signs of wear. A secondary safeguard that holds the plate in the event of a cylinder failure or hydraulic fluid leak should be standard in the manufacturing of these units.

- 2. Information:** The manufacturer must supply information regarding the proper installation, operation, and maintenance of the units.
- 3. Training:** It is essential that employees be trained in proper procedures and maintenance of these units. All users must keep all parts of their bodies out of the machine at all times, except to enter the unit to remove the bale. When it is necessary to remove the baled cardboard, there must be a way of blocking the plate so it cannot fall on a worker inside.
