HAZARD ALERT

WORKER INJURED WHEN BYPASSING SAFETY DEVICES

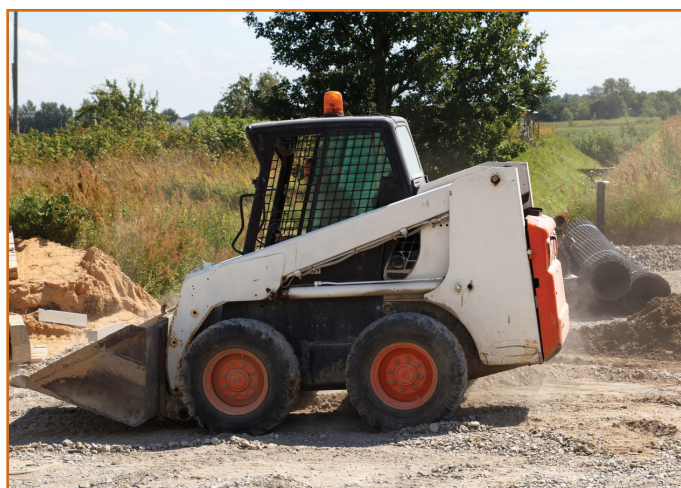
A skid steer loader is a small, quick-moving and powerful rubber-tired Machine, making it a versatile and potentially dangerous piece of equipment. When a worker inadvertently hit the foot pedals while boarding such a loader, the bucket was activated and pinned him against the roof's edge of the cab. The incident could have been fatal.

The type of skid steer loader involved was equipped with three safety devices:

- 17 kg (35 lbs) of pressure required in the seat to operate the arms and the bucket
- The seat belt has to be fastened to operate the arms and the bucket
- A safety bar has to be pulled down over the operator, once seated, to unlock the steering levers and foot pedals.

- The operator boarded a running machine.
- The operator entered head first and placed a hand on the seat, thereby creating enough pressure to disengage the first safety device.
- The seat belt fastened behind the seat disengaged the second safety device.
- The limit switch on the safety bar was not functioning, which prevented the third and last safety device from working properly.

1. An employer must ensure that powered mobile equipment is maintained in safe working condition and must replace or repair any defective parts before the equipment is operated. [Paragraphs 229(1)(a)(b) Regulation 91-191]
2. An operator of powered mobile equipment must stop the engine when leaving it unattended. [Subsections 228(c)(v) Regulation 91-191]
3. The manufacturer's specifications (recommendations) must be followed. [Subsection 235(1) Regulation 91-191]
4. Safety devices must never be altered [subsection 229.1 (1) Regulation 91-191] or bypassed.
